# BLACK RIVER TECHNICAL COLLEGE POCAHONTAS CAMPUS FLOOD PROTECTION PROJECT PRELIMINARY ENGINEERING REPORT

May 2019

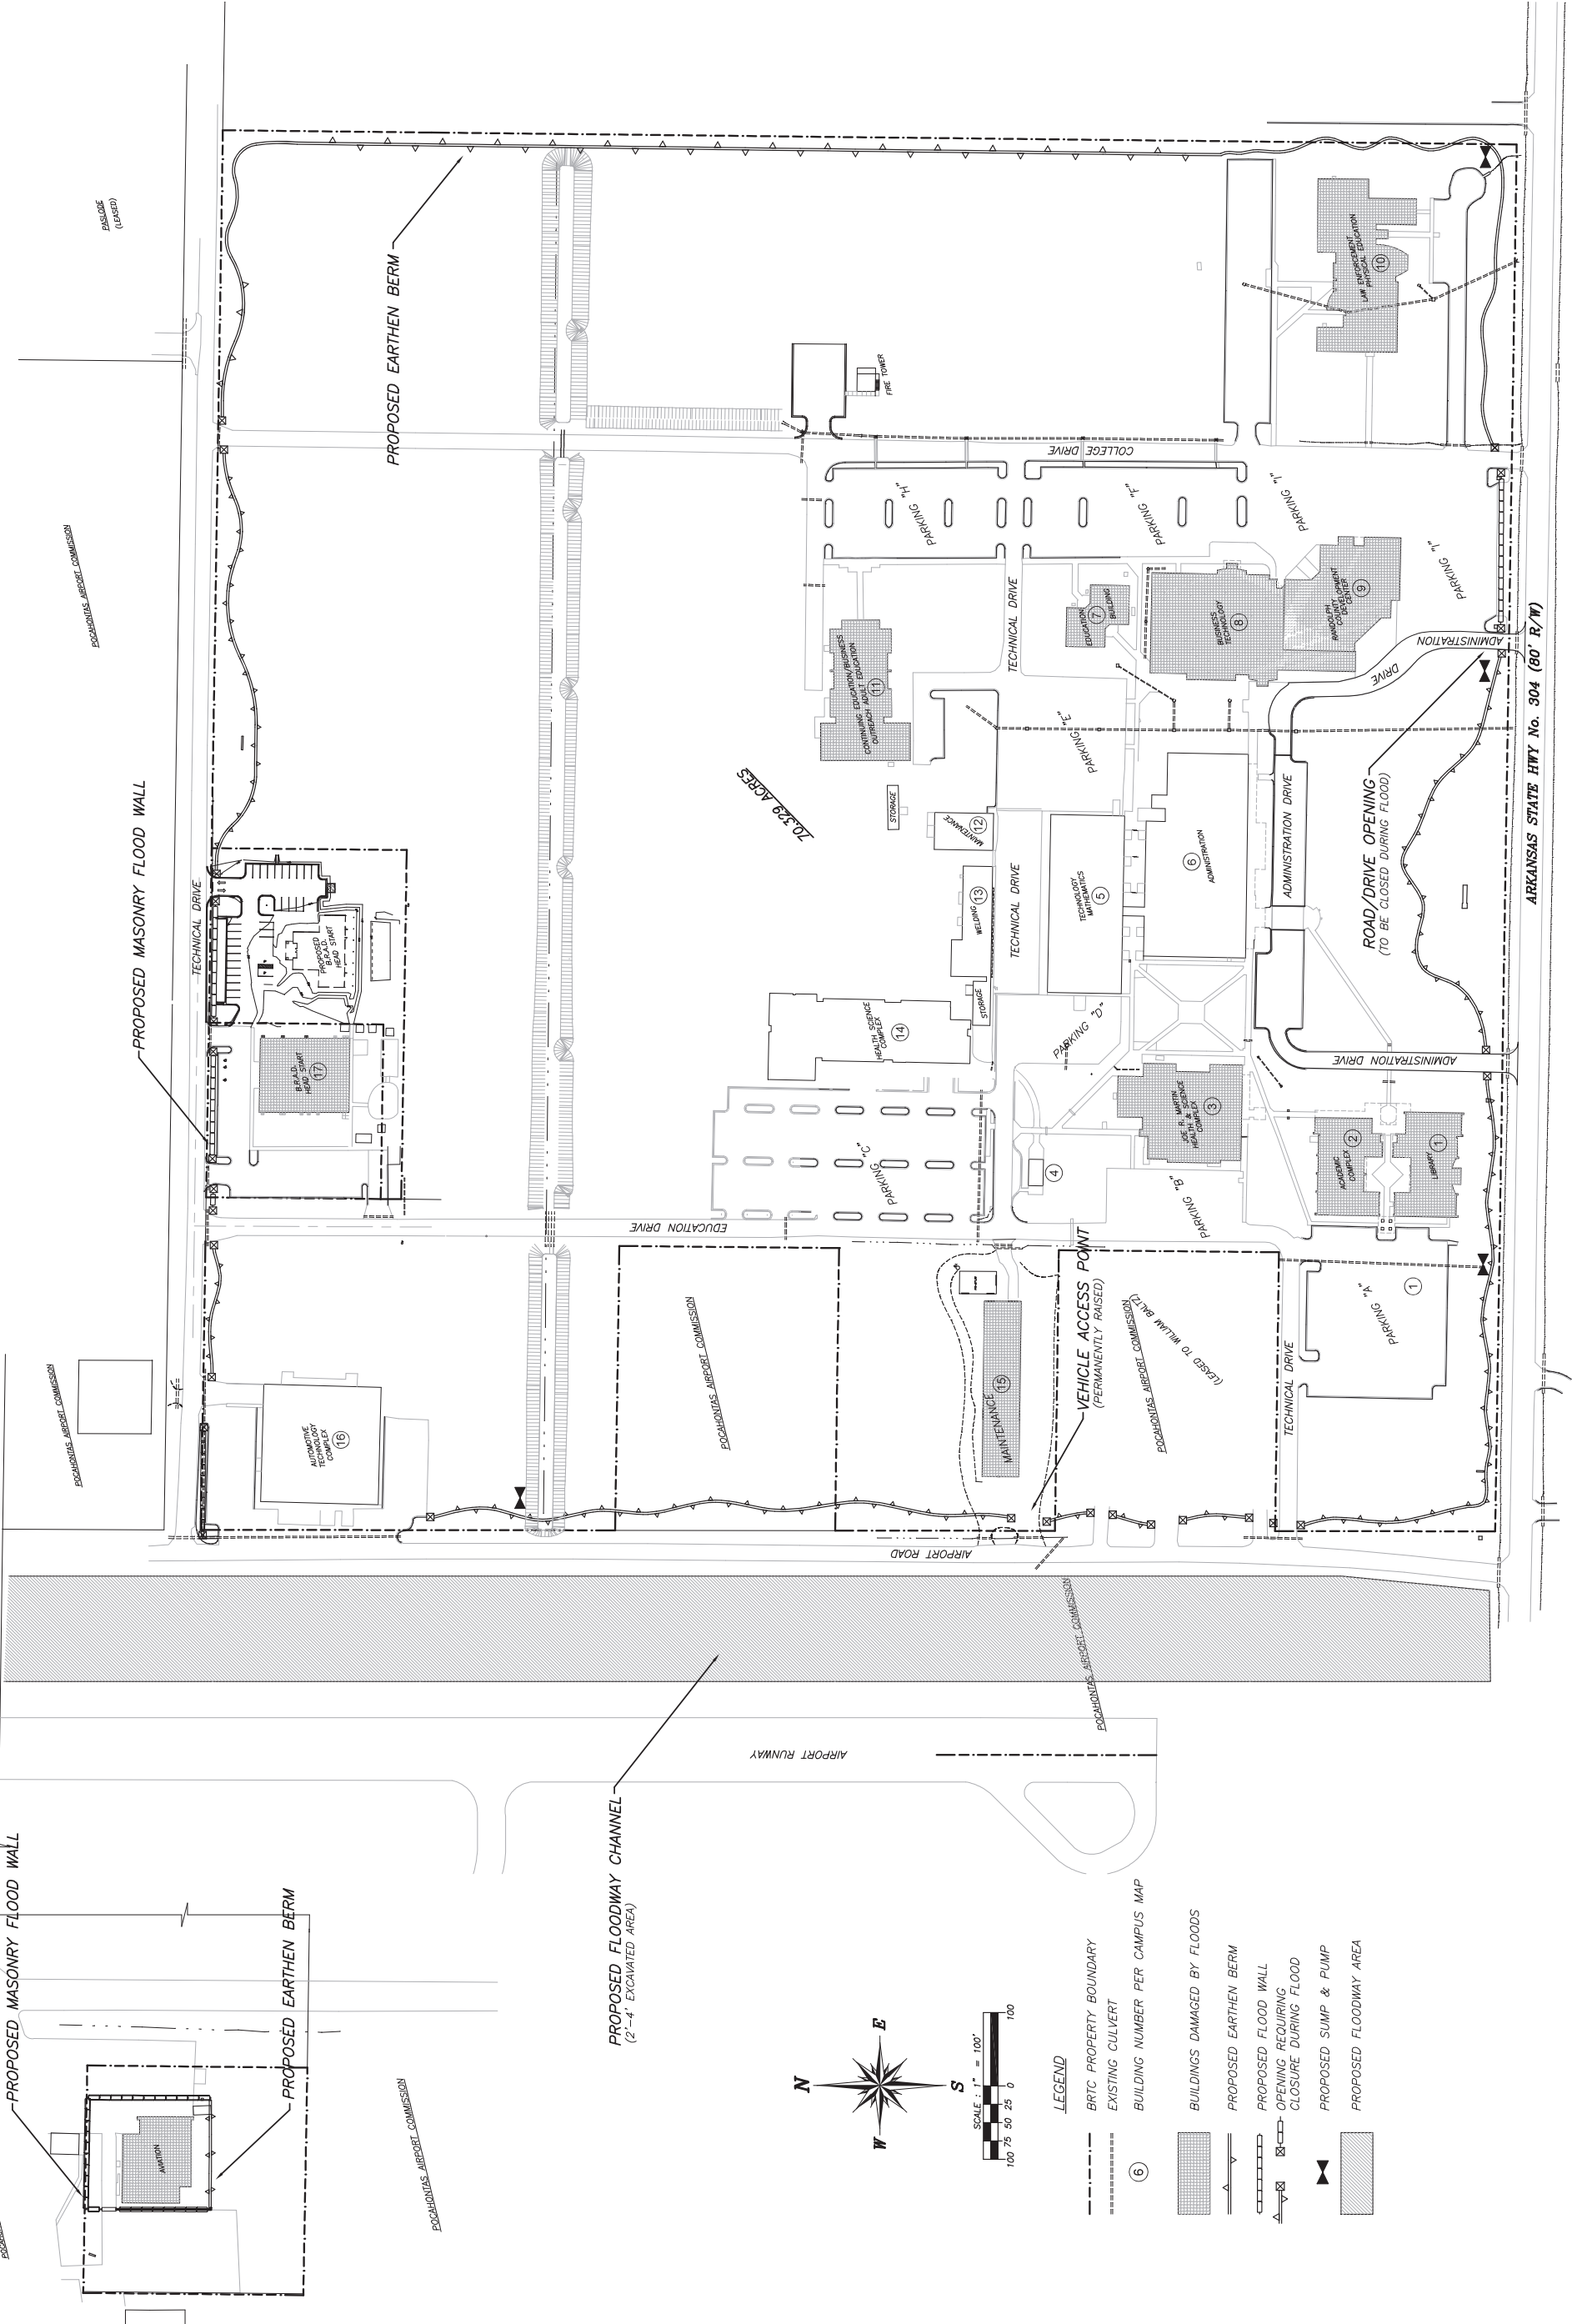
SECTION VIEW - EARTHEN BERM  
NOT TO SCALE

USED IN ALTERNATIVE 2

Campus floods are relatively shallow and historically have been short in duration. A system of earthen berms, permanent walls, sumps, and a relief area could protect the entire main campus area. The earthen berms would range in height from 2 to 5 feet and would be constructed in open areas where space is available. More confined areas would require a masonry wall. The berms can be designed with random curves and varying height to improve aesthetics. Masonry walls can be designed with decorative finishes that would blend in with the campus architecture. Roadways and drives would be left open and require closure during flood events. Existing drainage would require control structures to prevent backflow, and pumping of seep water and rainfall will be required in multiple locations. A relief area, or floodway, could be required in order to pass the floodwater blocked by the berms and walls to prevent increasing damage to neighboring property.

A general plan of this alternative is shown on Plan Sheet 2 of 3; details are shown on Plan Sheet 3 of 3.

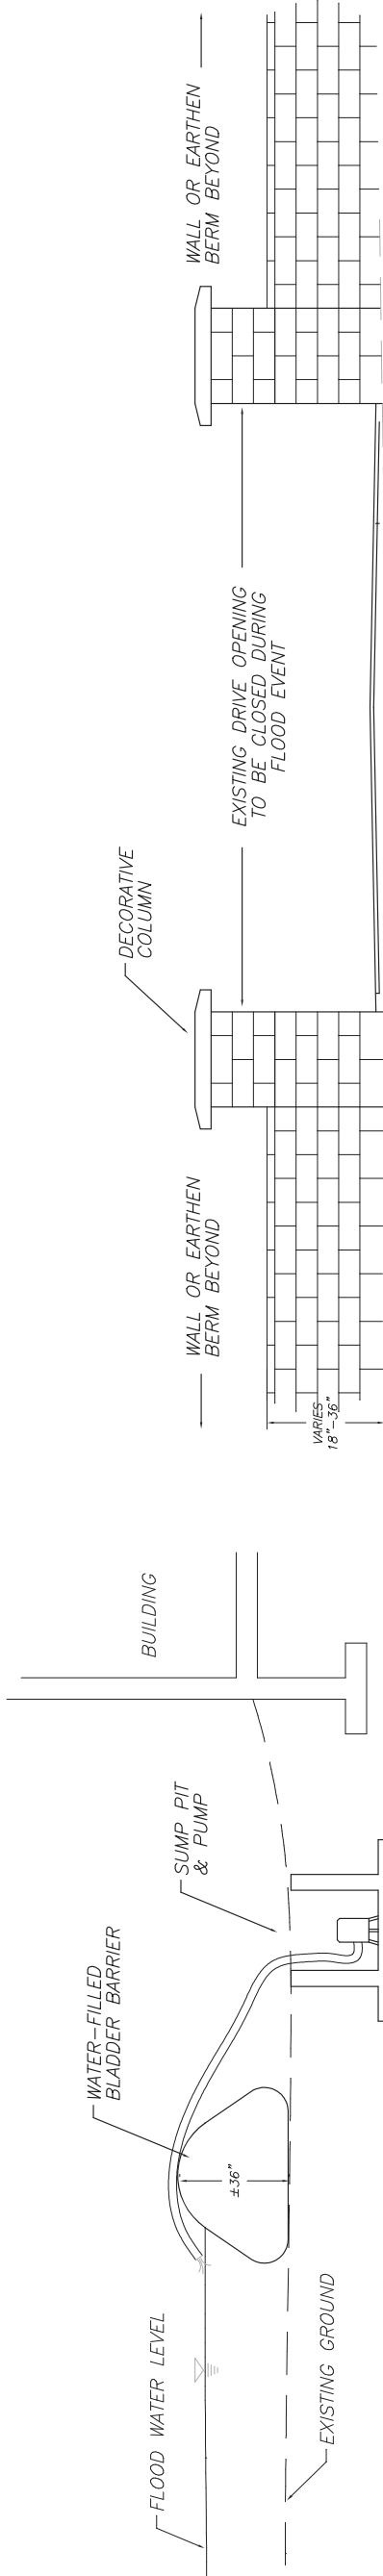
SECTION VIEW - TEMPORARY BLADDER BARRIER & SUMP  
NOT TO SCALE

USED IN ALTERNATIVE 1

Protection can be achieved with temporary barriers (bladders) that would be deployed before a flood event for only the flood prone buildings. Bladders consist of heavy gauge vinyl tubes that are rolled out and filled with water to form a barrier. These would be used in parking and drives, and where permanent walls cannot be placed.

In addition to deploying the bladders, each area protected in this manner will require closure of building entrances (doors) and plugging all utility lines entering the buildings. Each area will also require a sump and pump in order to collect and eliminate seep water and to handle rain events during a flood.

A general plan of this alternative is shown on Plan Sheet 1 of 3; details are shown on Plan Sheet 3 of 3.
